## **AIRCRAFT ACCIDENT INVESTIGATION BOARD**

### **FINAL AIRCRAFT ACCIDENT REPORT FOR A BOMBARDIER DASH 8 Q311, 9J – PZB THAT OCCURRED IN NAMPUNDWE, CENTRAL PROVINCE, ZAMBIA ON 25<sup>th</sup> NOVEMBER, 2019.**

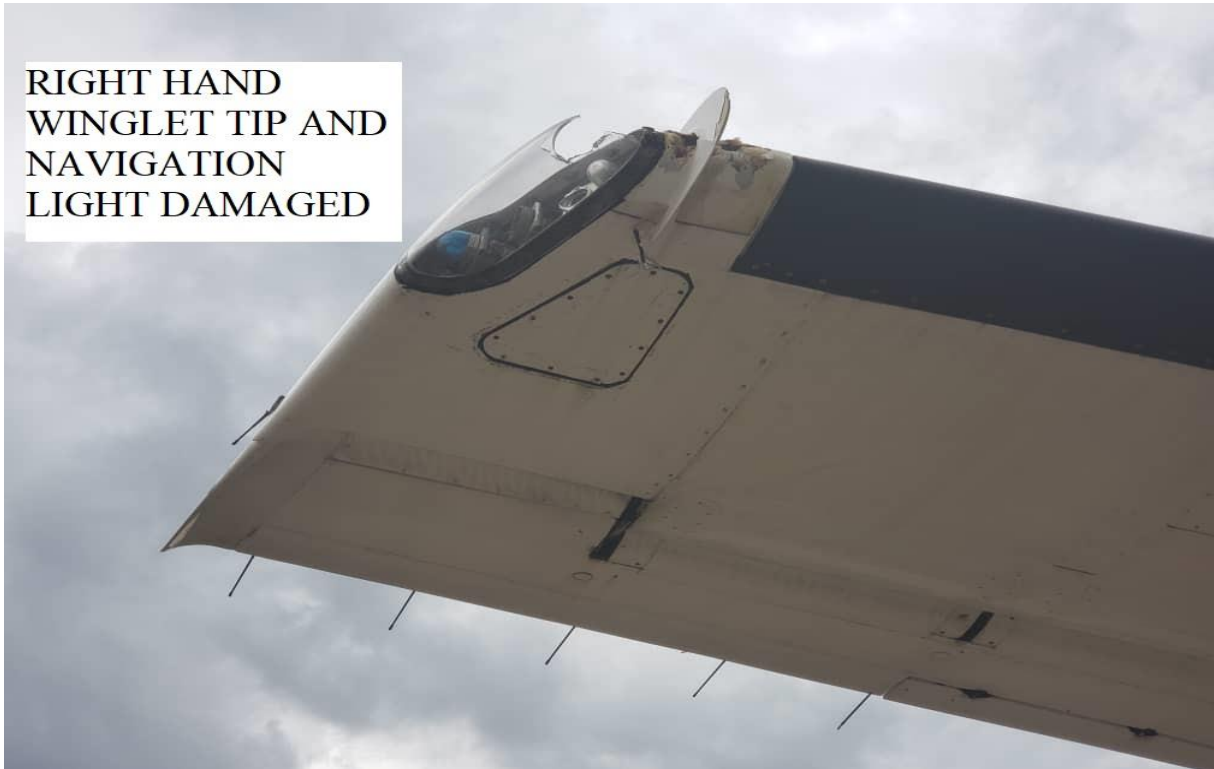
Fig. 2 Right Hand Winglet Tip and Navigation Light

- Right hand Winglet tip and Navigation light was damaged. (Fig. 2)
- Radome /Nose Cone Panels were damaged (Fig. 3)
- Left Hand Leading Edge Wing Root Fairing was damaged(Fig. 4)
- Right Hand Wing Root was severely broken (Fig. 5)
- Leading Edge Horizontal Stabilizer paint was scraped off on one end
- Leading Edge Horizontal Stabilizer including the Lens Covers were damaged [Top] (Fig. 6)
- Taxi and Landing Lights were broken (Fig. 7)

- a) Right hand Winglet tip and Navigation light (Fig.2)
- b) Radome /Nose Cone Panels (Fig.3)
- c) Left hand Leading Edge Wing Root Fairing (Fig.4)
- d) Right Hand Wing Root (Fig.5)
- e) Leading Edge Horizontal Stabilizer paint (Fig.6)
- f) Leading Edge Horizontal Stabilizer and Lens Covers [Top] (Fig.6)
- g) Taxi and Landing Lights (Fig.7).

**RIGHT HAND  
WINGLET TIP AND  
NAVIGATION  
LIGHT DAMAGED**

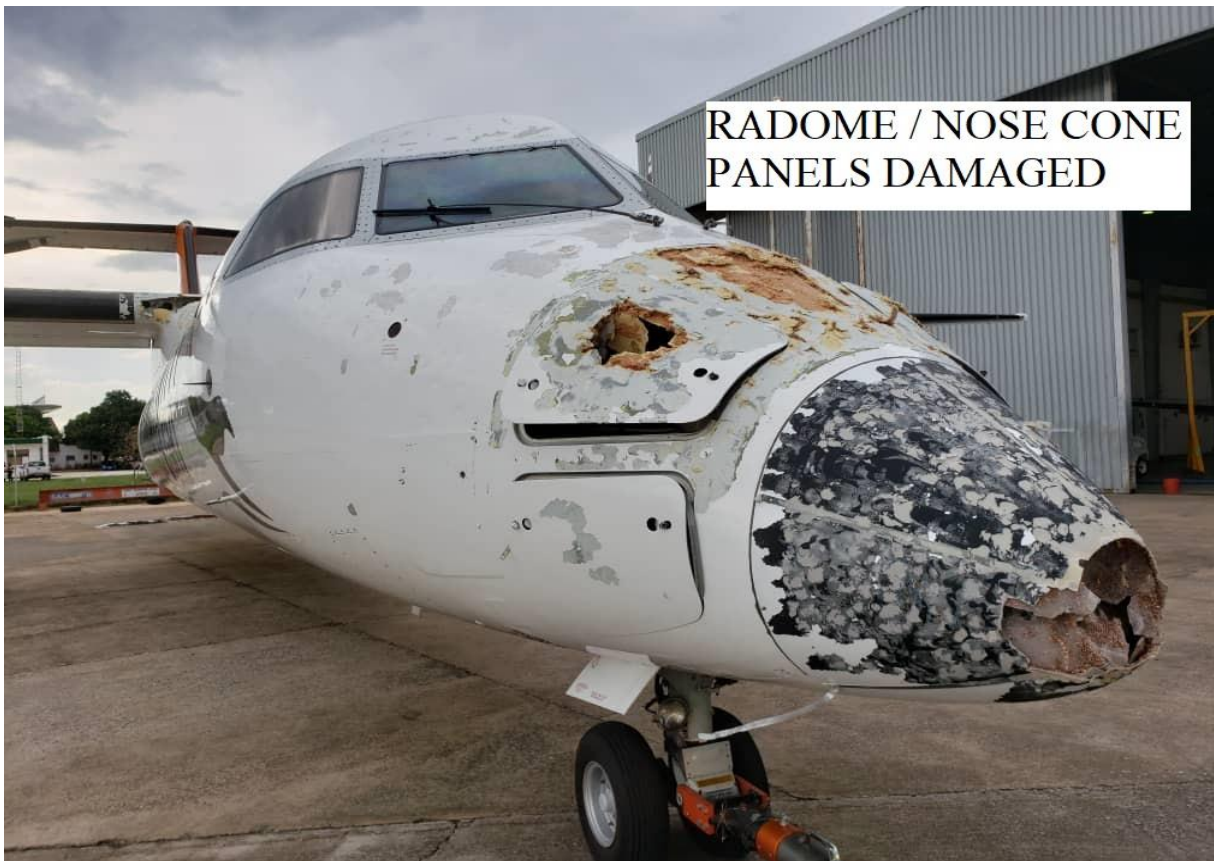
Fig. 3 Radome /Nose Cone Panels

**RADOME / NOSE CONE  
PANELS DAMAGED**

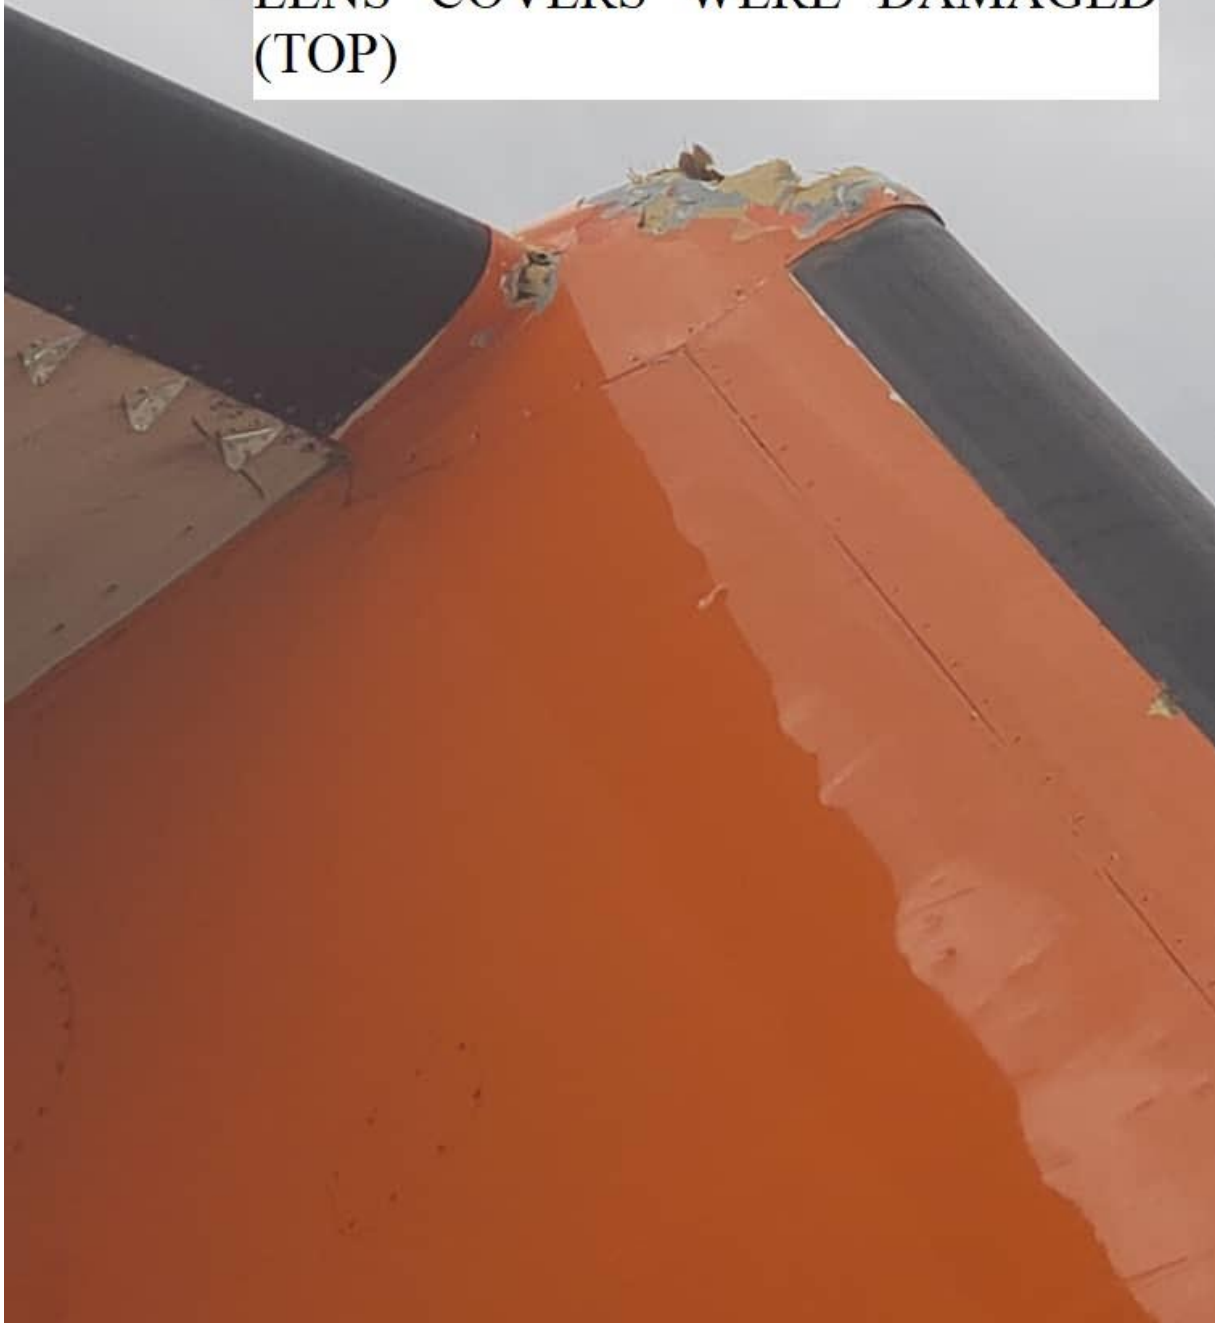
Fig. 6 Leading Edge Horizontal Stabilizer and Lens Covers

LEADING EDGE HORIZONTAL  
STABILIZER INCLUDING THE  
LENS COVERS WERE DAMAGED  
(TOP)
