AIRCRAFT ACCIDENT INVESTIGATION BOARD

FINAL AIRCRAFT ACCIDENT REPORT FOR A CESSNA U206C, REGISTRATION 9J-RHE THAT OCCURRED ON 11th JUNE, 2022 IN THE LUANO VALLEY, CENTRAL PROVINCE, ZAMBIA

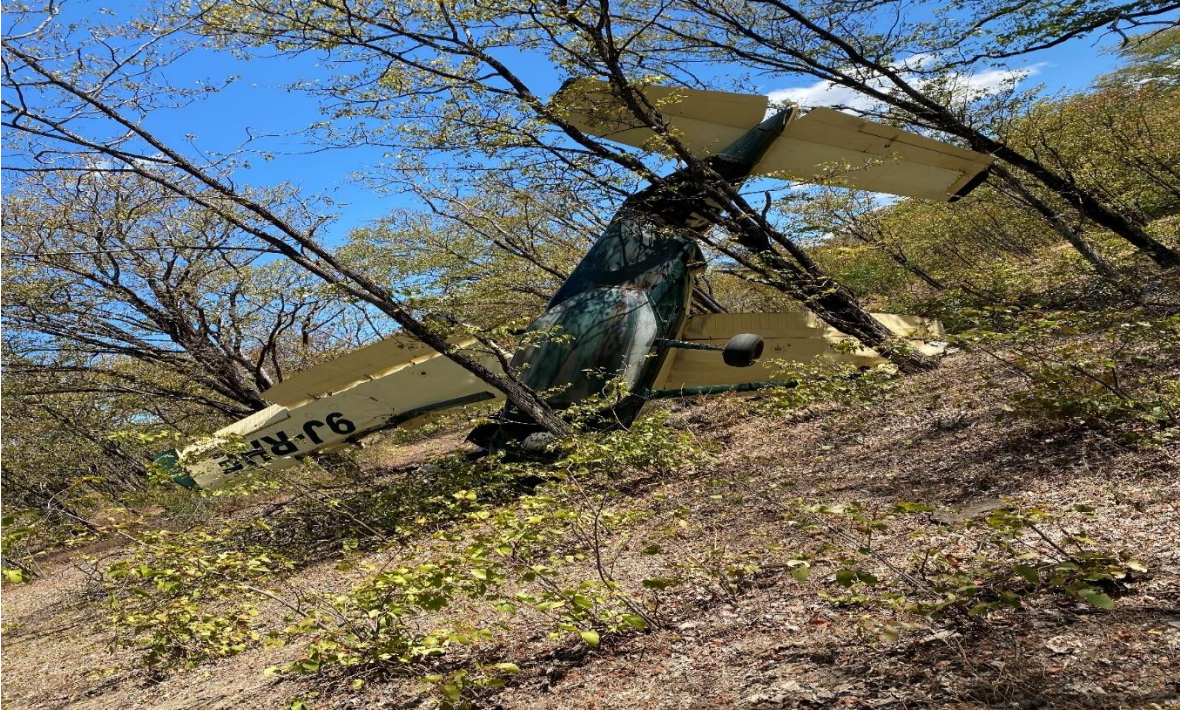
The aircraft's right wing made first impact with a tree forcing the aircraft to turn right with its nose down. The aircraft went on to crash into the ground with its nose down, uprooting a few trees (Fig.7a and 7b) and finally was stopped by two trees where it rested with its tail up (Fig.1). The aircraft crashed about 46 nm away from Lusaka in the heading of 120 degrees at about 1,800 feet elevation. The First Officer's and Pilot in Command (PIC) instruments were visually intact.

Fig. 1: 9J-RHE Resting Position

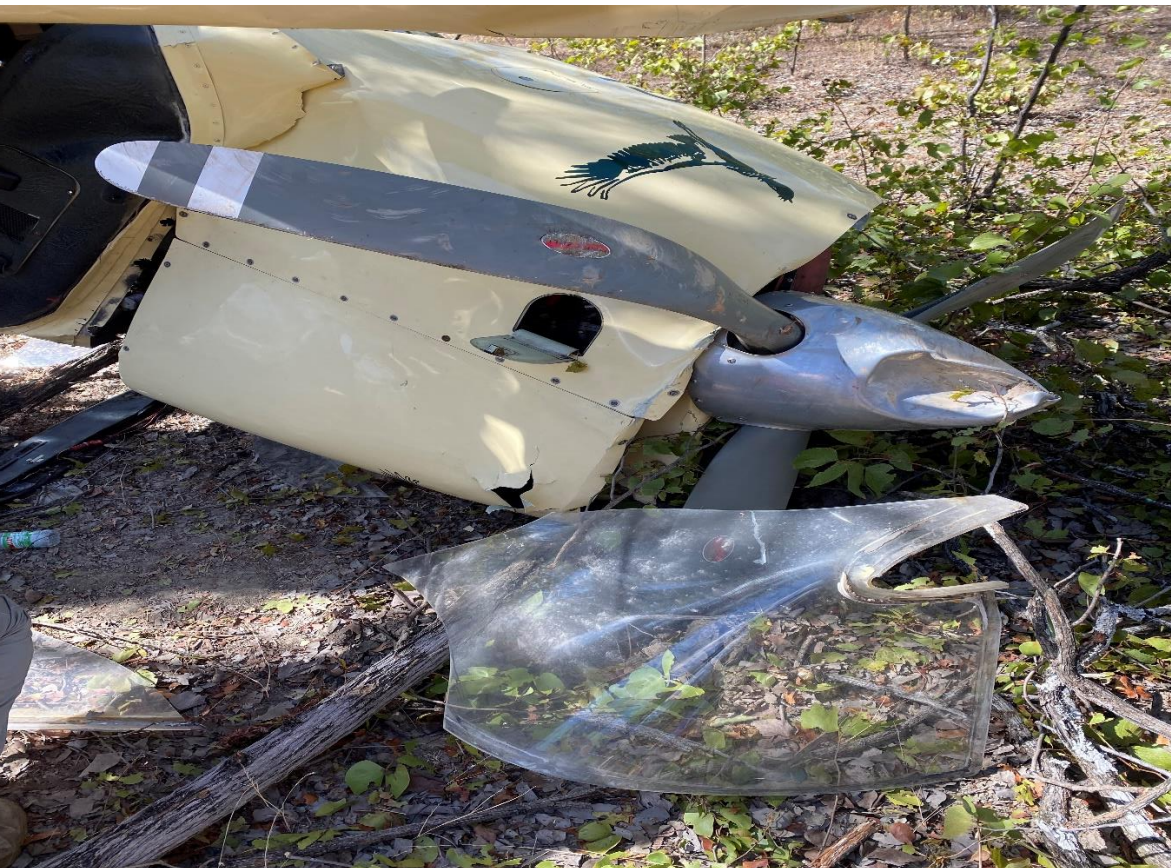
- a) Propeller damaged with one propeller blade bent backwards and broken windshield pieces (Fig.2)
- b) Right wing damaged and detached folded at the wing tip (Fig.3)
- c) Left wing damaged and partially detached from aircraft fuselage (Fig.4a and Fig.4b)
- d) Engine cowlings partially damaged (Fig.5)
- e) Tail section bent and damaged (Fig.6)

Fig.2: Propeller Damaged with One Propeller Blade Bent Backwards and Broken Windshield Pieces

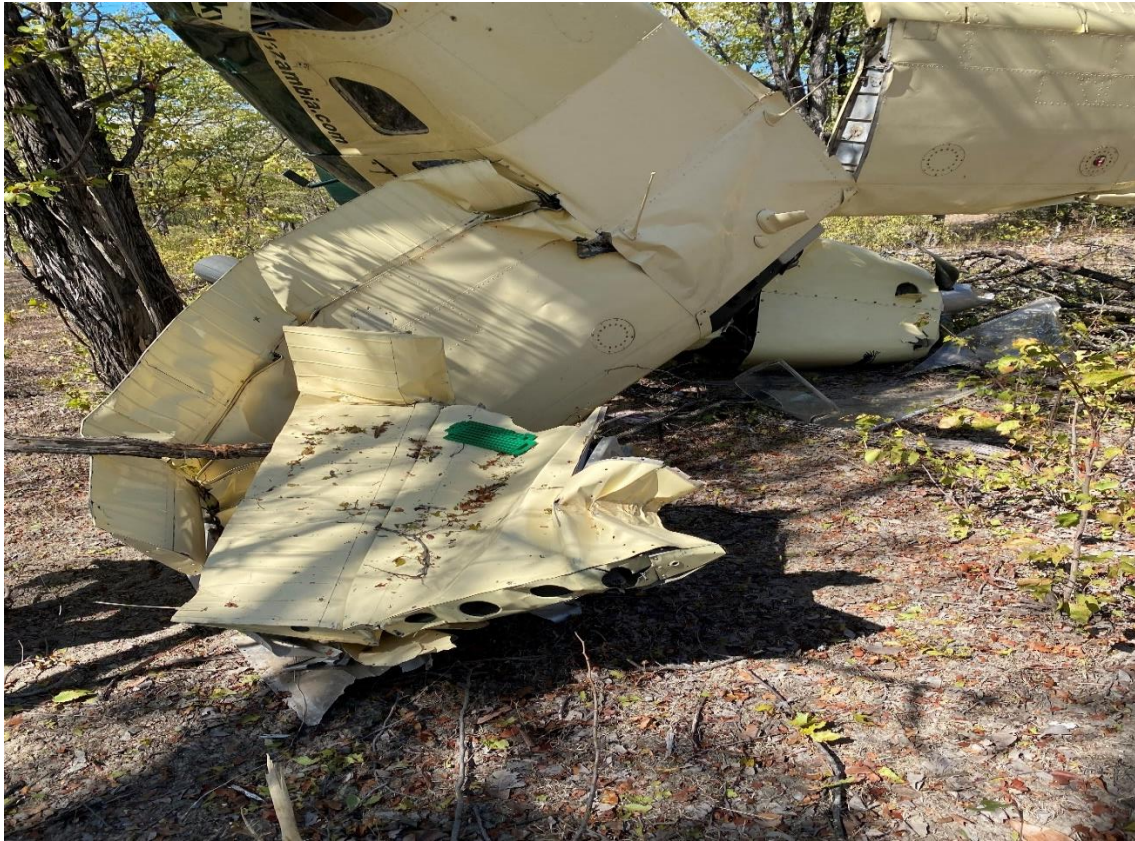
Fig.3: Right Wing Damaged and Folded

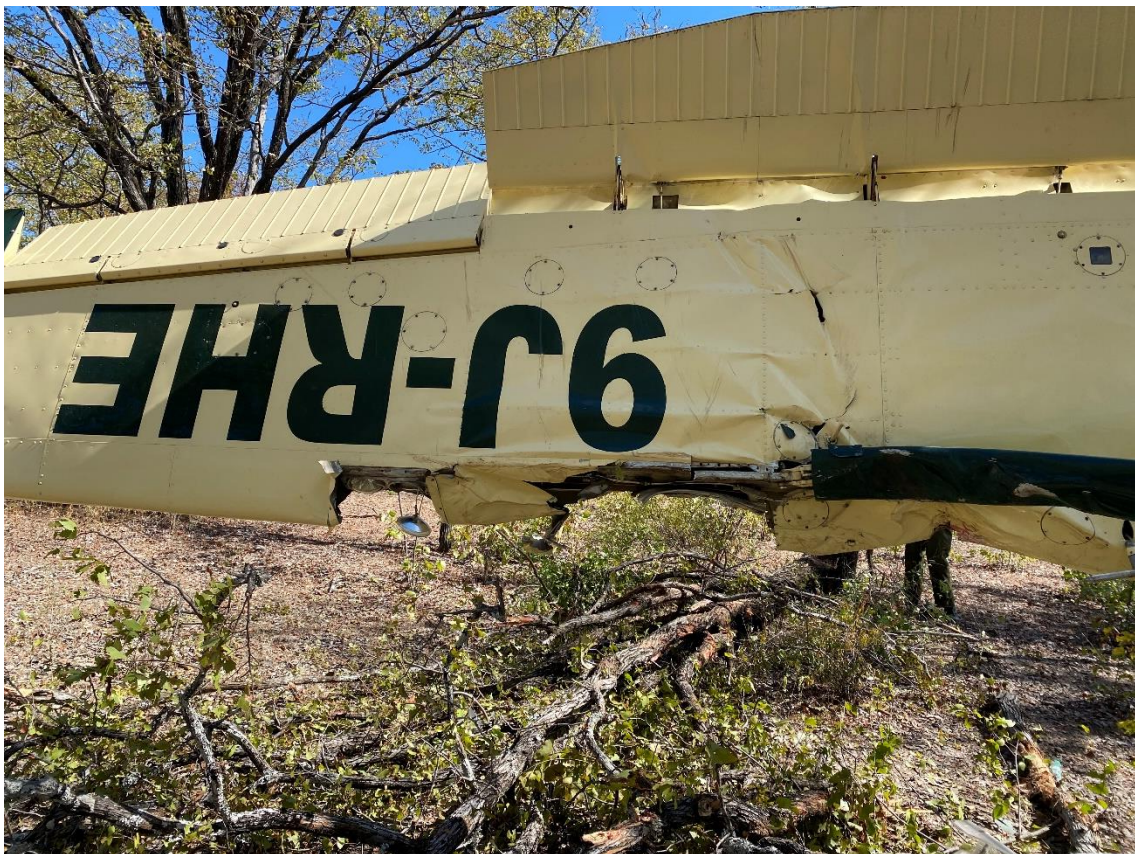
Fig.4a: Left Wing Damaged

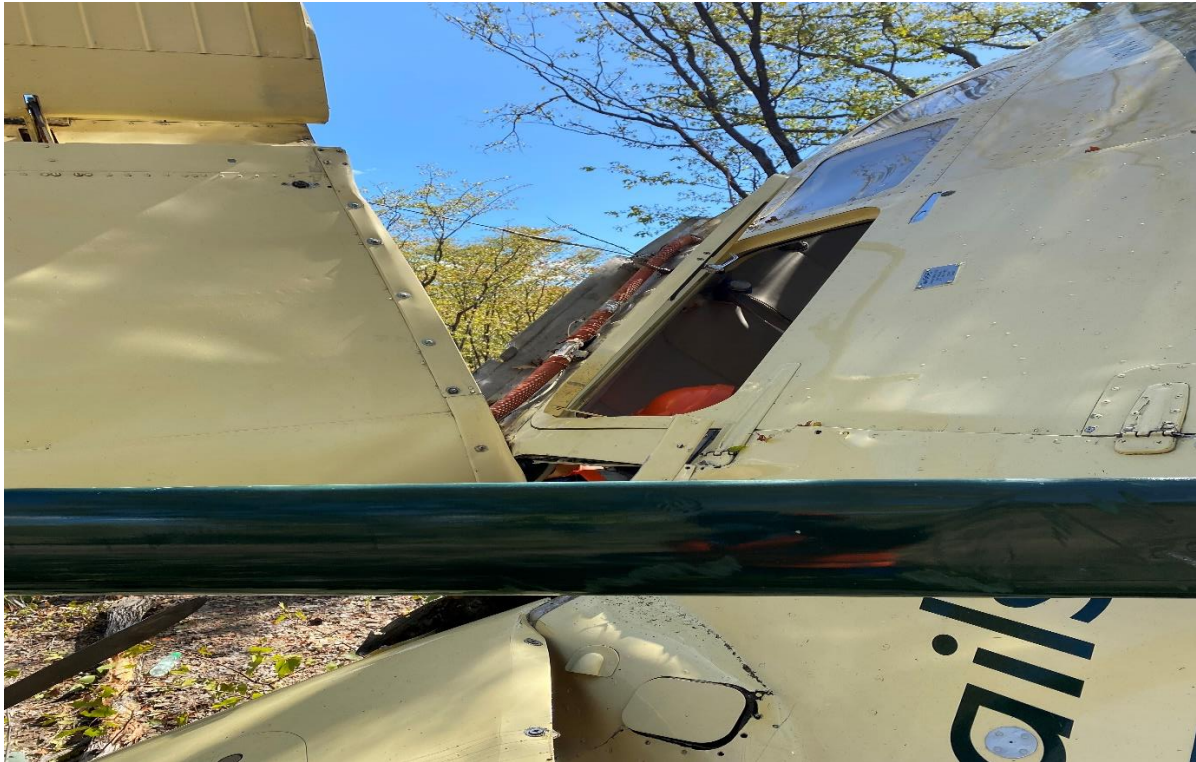
Fig.4b: Left Wing Partially Detached from Aircraft Fuselage

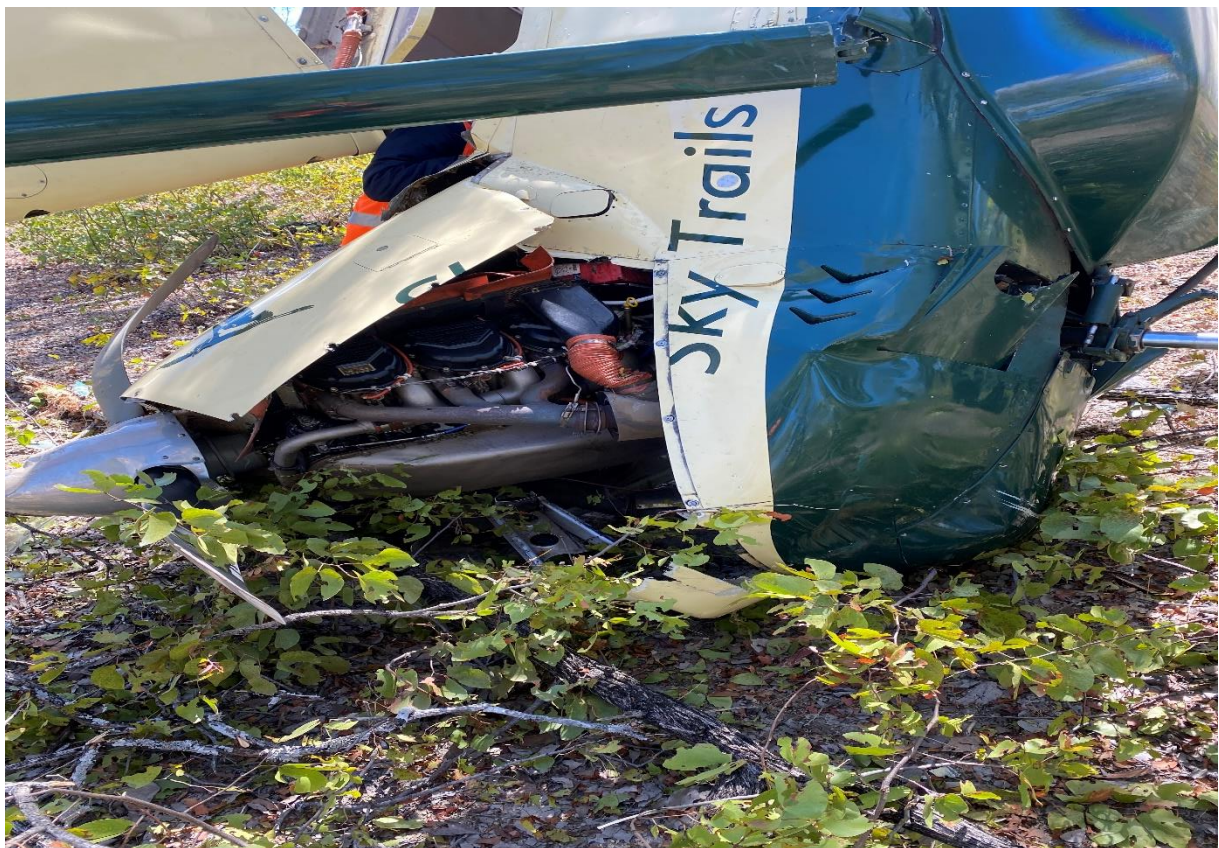
Fig. 5: Engine Cowlings Damaged and Unmounted

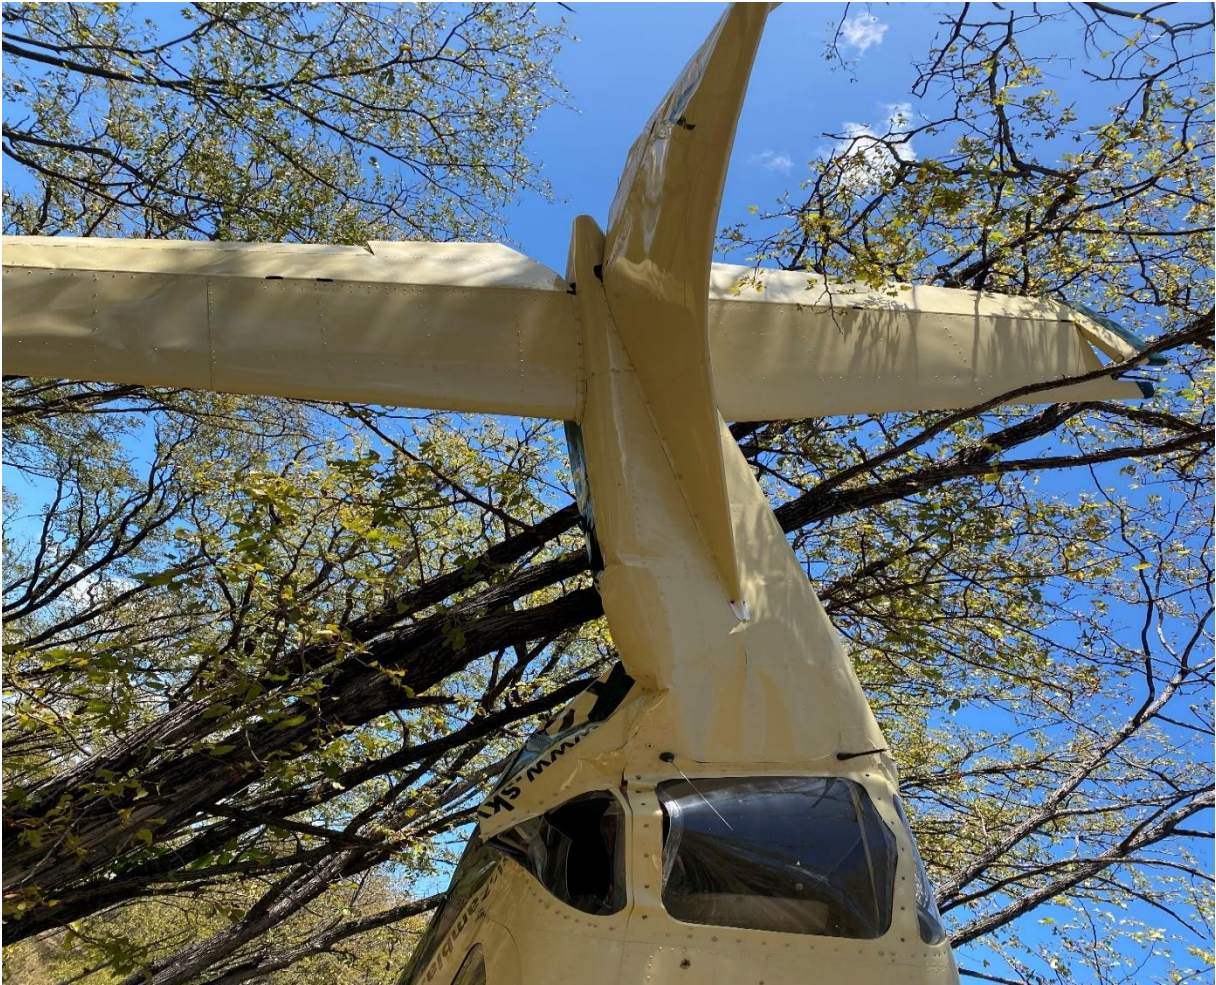
Fig.6: Tail Section Bent and Damaged

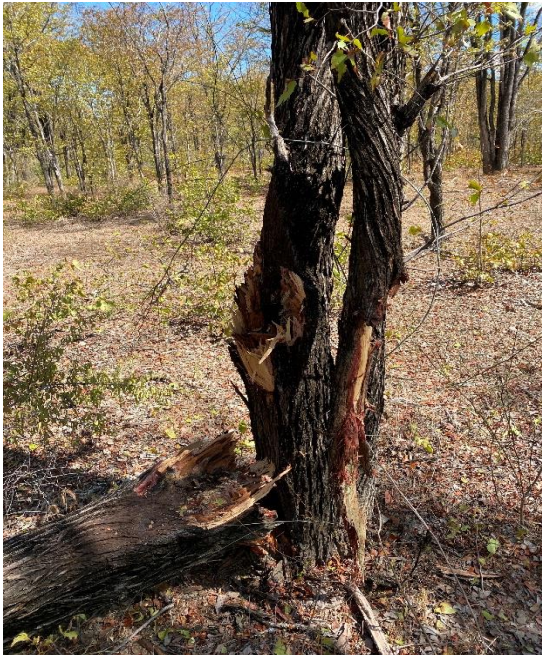
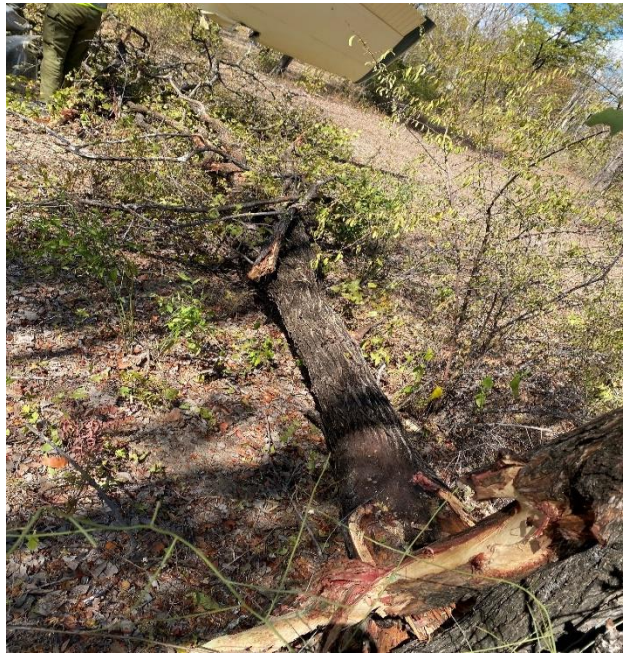
Fig.7a: Trees Impacted by Aircraft

Fig.7b: Trees Impacted by Aircraft

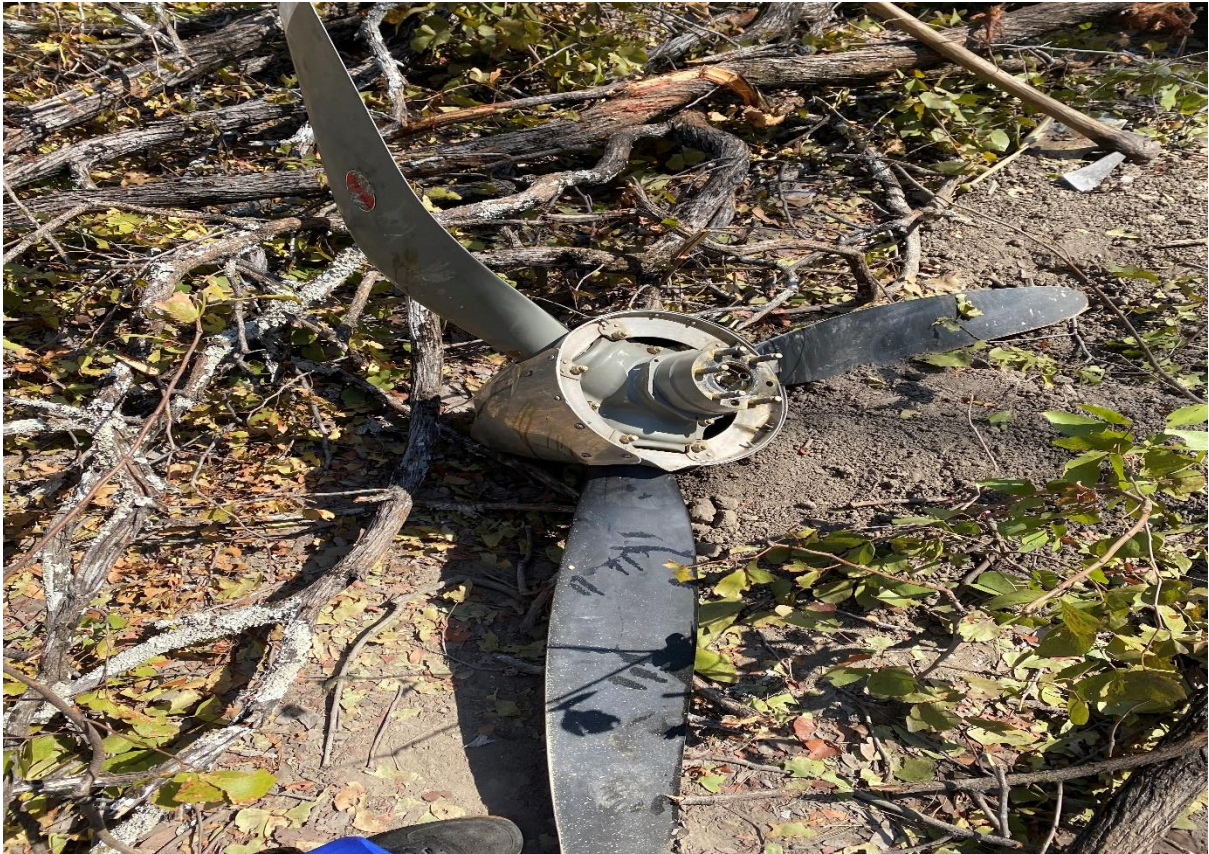
S/N	COMPONENT/ SYSTEM	STATE FOUND		COMMENT
01	Propeller (Fig.8)	One propeller blade found bent backwards while the other two were straight.		This indicates that the propeller was not spinning at impact.
02	Fuel Divider (Fig.9)	Diaphragm clean and not collapsed		Fuel system not blocked and fuel was flowing.
03	Spark Plugs (Fig.10)	Top Left	clean	All top spark plugs were firing. Bottom spark plugs found clean indicate firing.
		Top Right	clean	
		Bottom left	clean	
04	Throttle, Mixture and Propeller levers	All links connected		This indicates that the throttle, mixture and propeller controls were working and responsive.
05	Fuel Selector	Link connected		This indicates that the fuel selector was working.
06	Fuel Supply System (From tanks to engine) [Fig.12 to Fig.14]	Left Tank	Fuel Flow Normal	This indicates that there was no blockage or leakage in the flow of fuel from the tanks to the engine.
		Right Tank	Fuel Flow Normal

Fig.8: Propeller with One Propeller Blade Bent

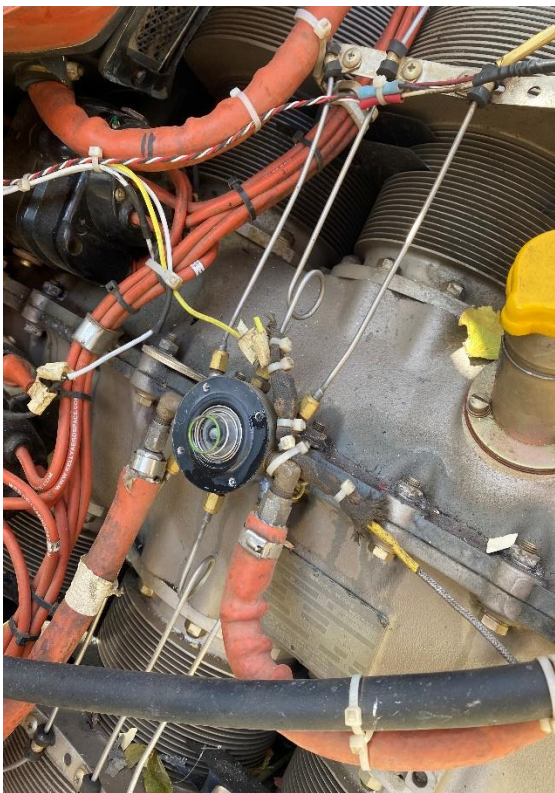
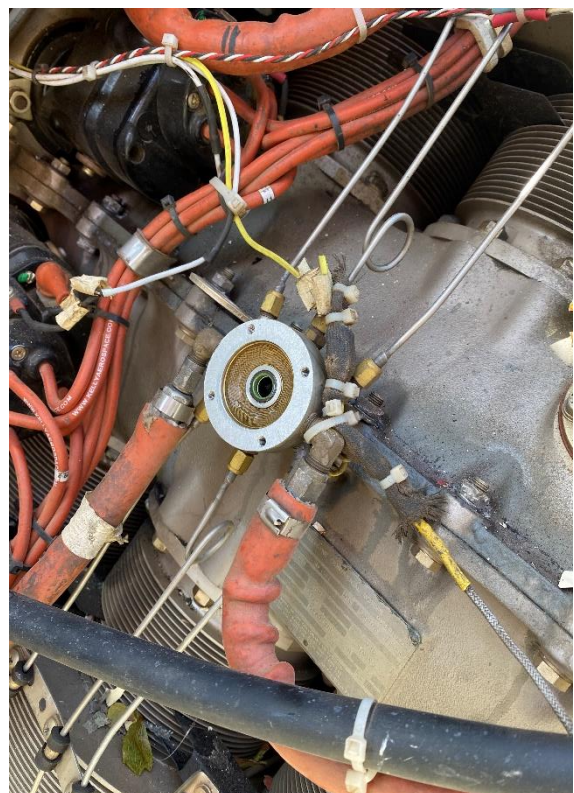
Fig.9: Fuel Divider and Diaphragm

Fuel flow divider was found clean and the diaphragm did not collapse – this indicates that there was no blockage and fuel was flowing.

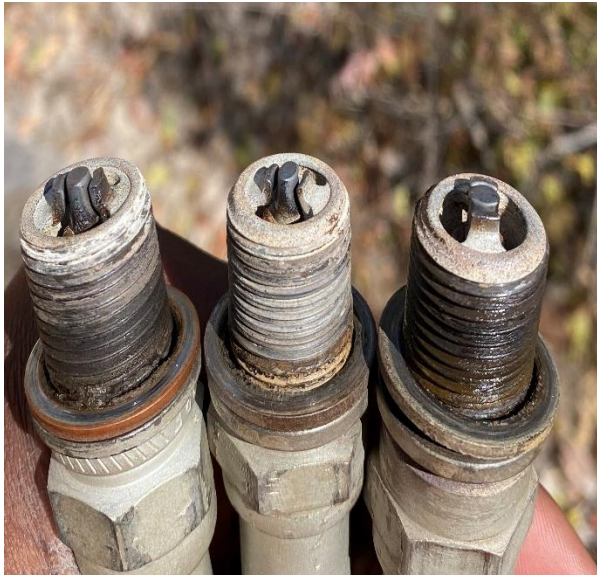
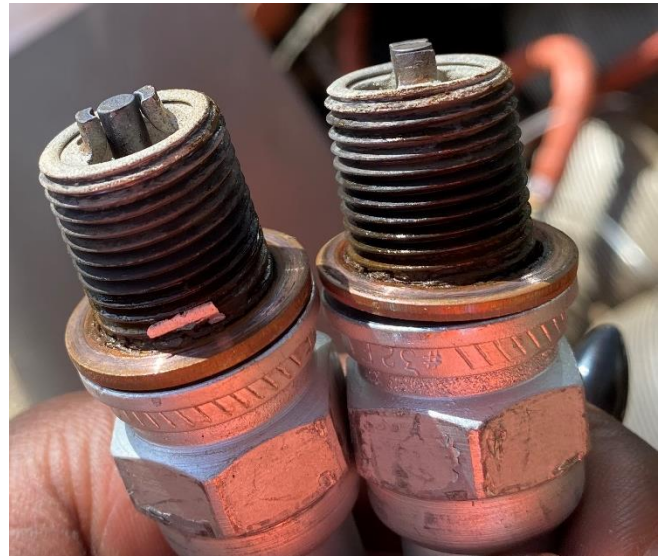
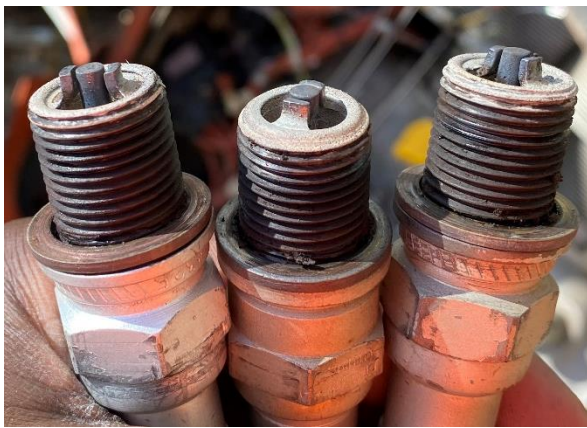
Fig.10: Spark Plugs

- b) **Ignition system failure** – The investigation finds that the ignition system did not fail as the spark plugs were serviceable. In addition, physical examination of the spark plugs indicate that the magnetos were in working order.
- c) **Air starvation** – there was no air starvation to the engine as the air filter was found clean and there was no blockage in the air induction system.
- d) **Mechanical linkages** – the three power levers (propeller, throttle and mixture) were connected and functioning normally.
- e) **Propellers** – the investigation finds that the state of the propeller as evidenced by the one propeller blade bent backwards while the other two were straight indicates that the engine was not running at impact.

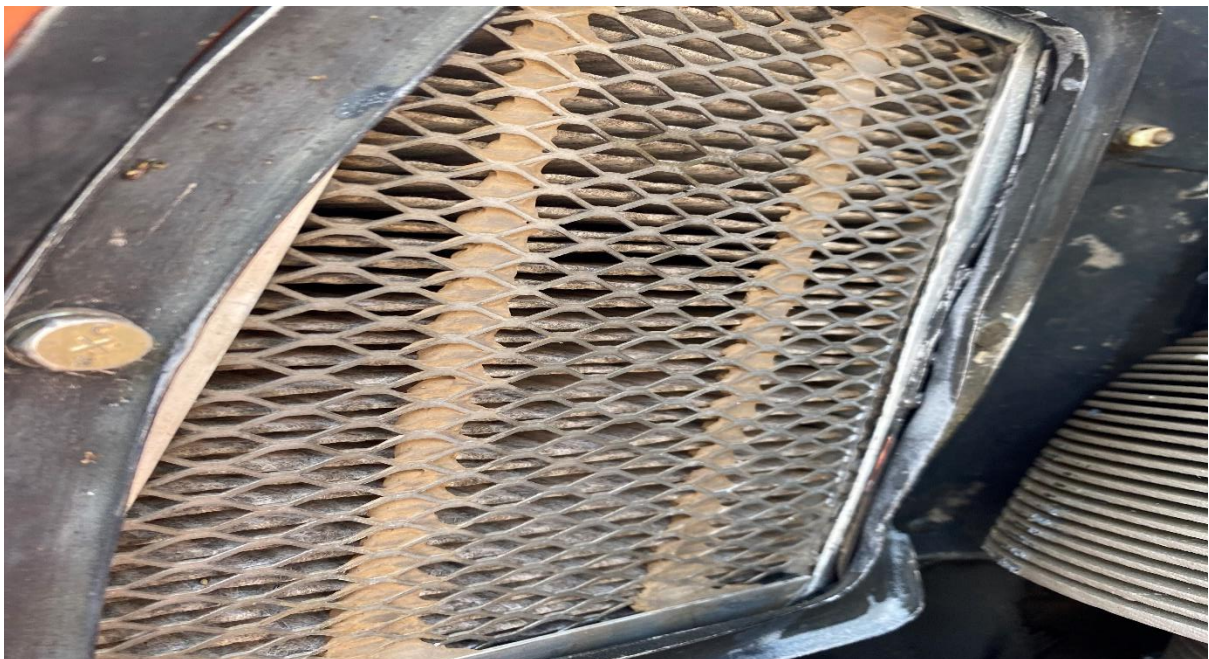
Fig.11: Air Filter

08	Air Filter (Fig.11)	Clean	No blockage on air filter.
09	Magnetos	Physically examined	The team found the presence of battery acid and burnt terminal cables and therefore found it unsafe to run the aircrafts electrical systems. However, physical examination of the spark plugs indicated that the Magnetos were serviceable.

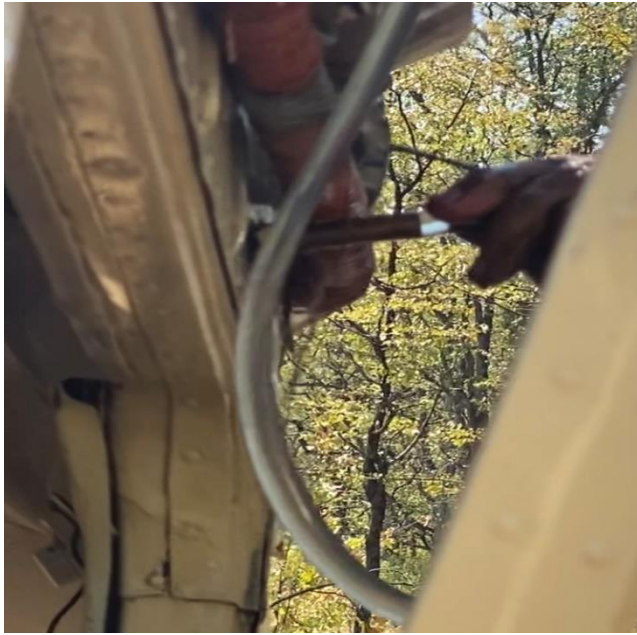
The team further carried out a test on the aircraft fuel system (Fig.12 to Fig.14) to see if there was any blockage to supply of fuel from the fuel tanks to the engine. The left side tank which resides in the left wing was unstable and therefore the wing was detached and fuel was fed directly into the fuel inlet on the aircraft fuselage (Fig.12). The result indicated that fuel was running all the way to the engine (Fig.13). The left wing was set at an angle and the unusable fuel was seen exiting the tank from the fuel exits. This showed the investigation team that the tank was intact. The right side was still attached to fuselage of the aircraft and therefore, fuel was poured directly into the tank. The team noted a very small leakage in the wing root attachment area. However, the test revealed that the fuel from the right fuel tank was reaching the engine with a significant amount of pressure (Fig.14).

Fig.12: Fuel Being Fed Directly Into the Left Side Fuel Inlet On the Aircraft Fuselage

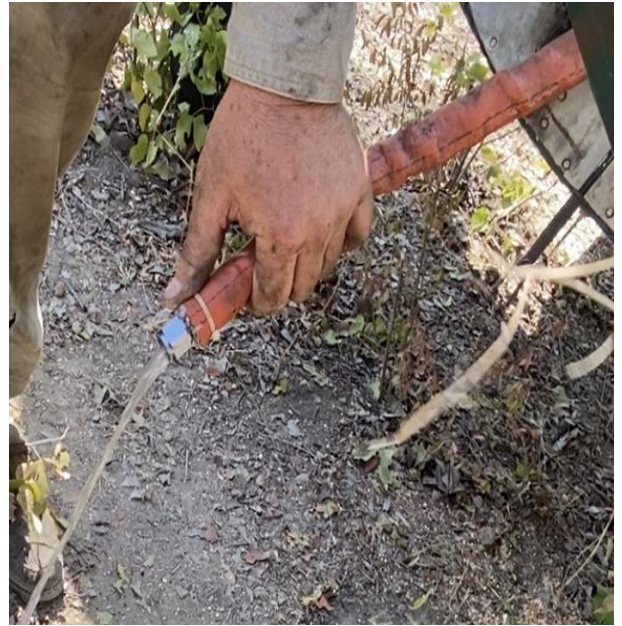
Fig.13: Fuel From the Left Side Fuel Inlet On Aircraft Fuselage Exiting at the Engine Outlet

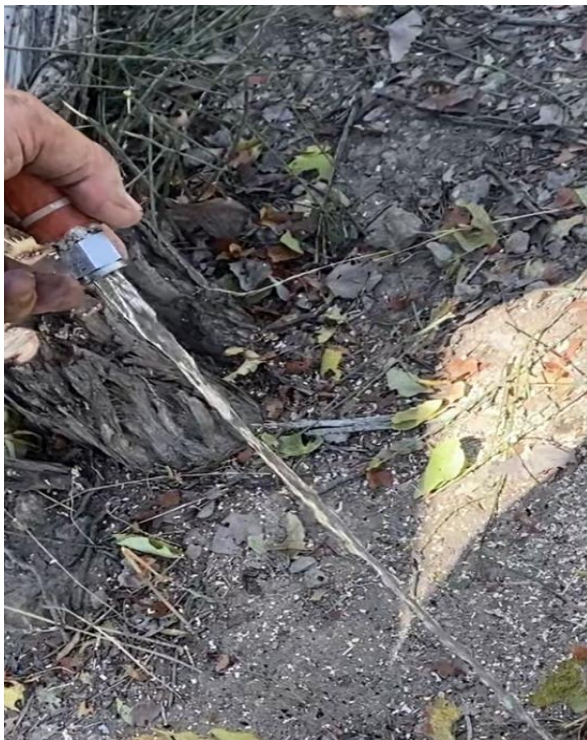
The test therefore revealed that the fuel system from the tanks to the engine was intact and undisturbed at the time of the accident.

Fig.14: Fuel from the Right Fuel Tank Exiting at the Engine Outlet

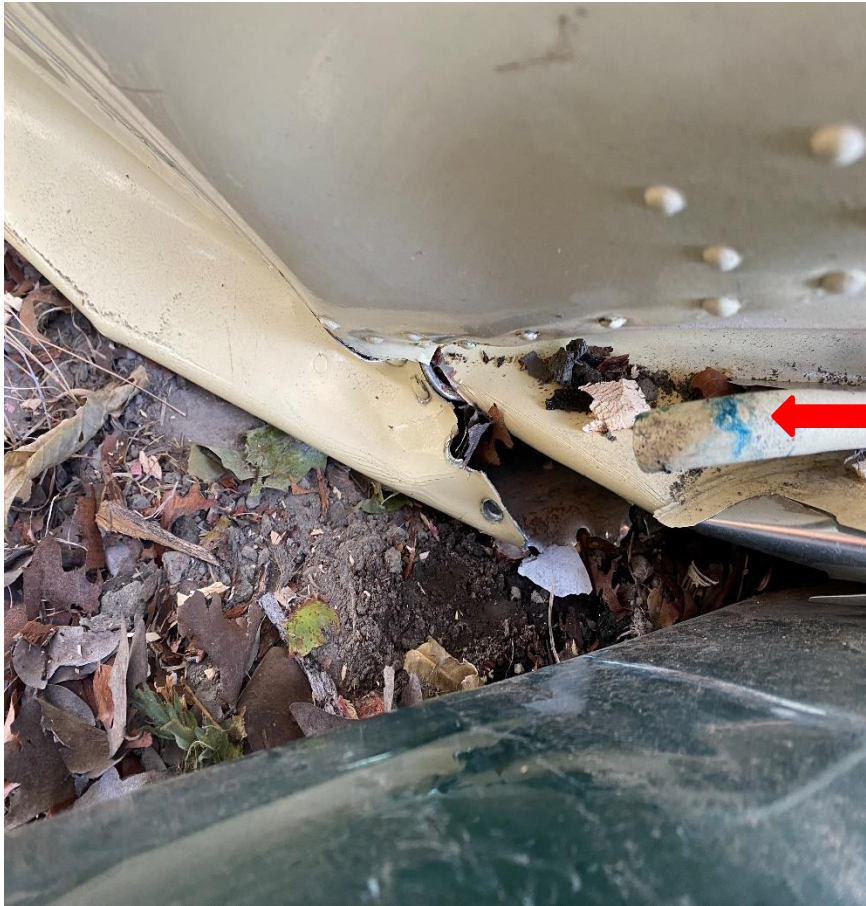
- d) It was observed that there was no fuel in both tanks and that there were no signs of fuel leakage in flight, on and after the impact. The aircraft fuselage did not exhibit signs of fuel leakage as there was no decolourisation of the aircraft surfaces (Refer to Fig. 15).

Decolourisation of aircraft surface in contact with fuel (Avgas 100LL)

Fig. 15: When fuel is in contact with the aircraft fuselage, decolourisation occurs as seen in the photo. This decolourisation occurred when the team was conducting on-site investigations.
