# AIRCRAFT ACCIDENT INVESTIGATION BOARD

# FINAL AIRCRAFT ACCIDENT REPORT FOR A CESSNA U206 9J-RHE THAT OCCURRED ON 3<sup>RD</sup> SEPTEMBER, 2019 IN SHIWANG'ANDU, MUCHINGA PROVINCE

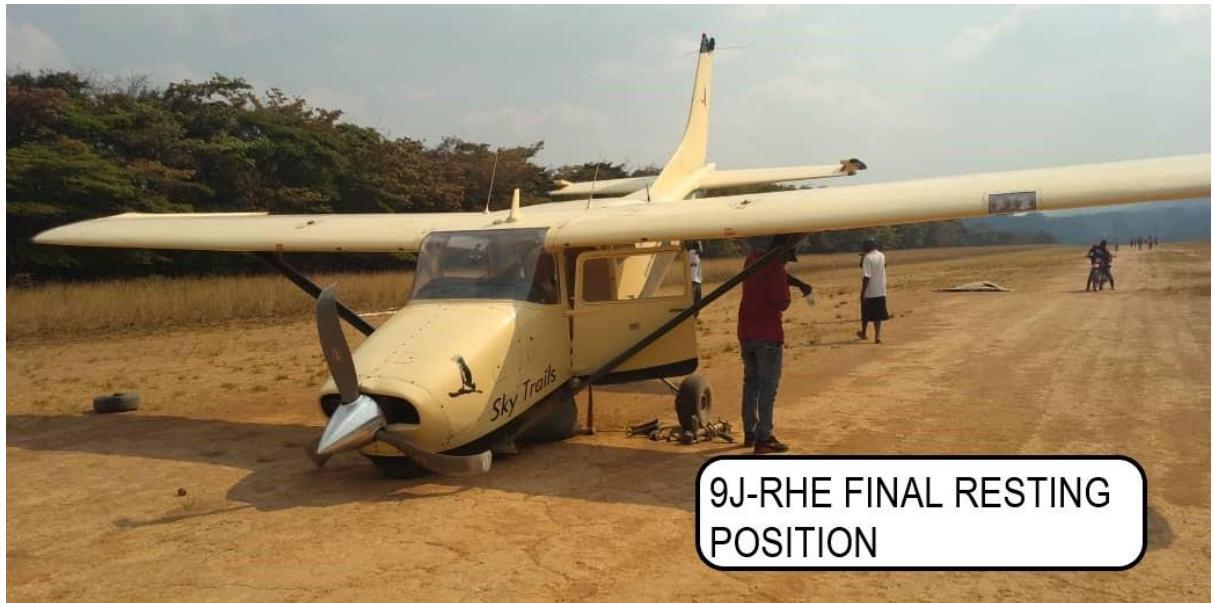
Fig.1: Final Resting Position of Aircraft

The aircraft suffered a detached baggage pod, ripped belly skin and broken nose landing gear strut. The torque links detached at the attachment to the strut while the body- to - strut link also broke off from the oleo strut (Fig.1).

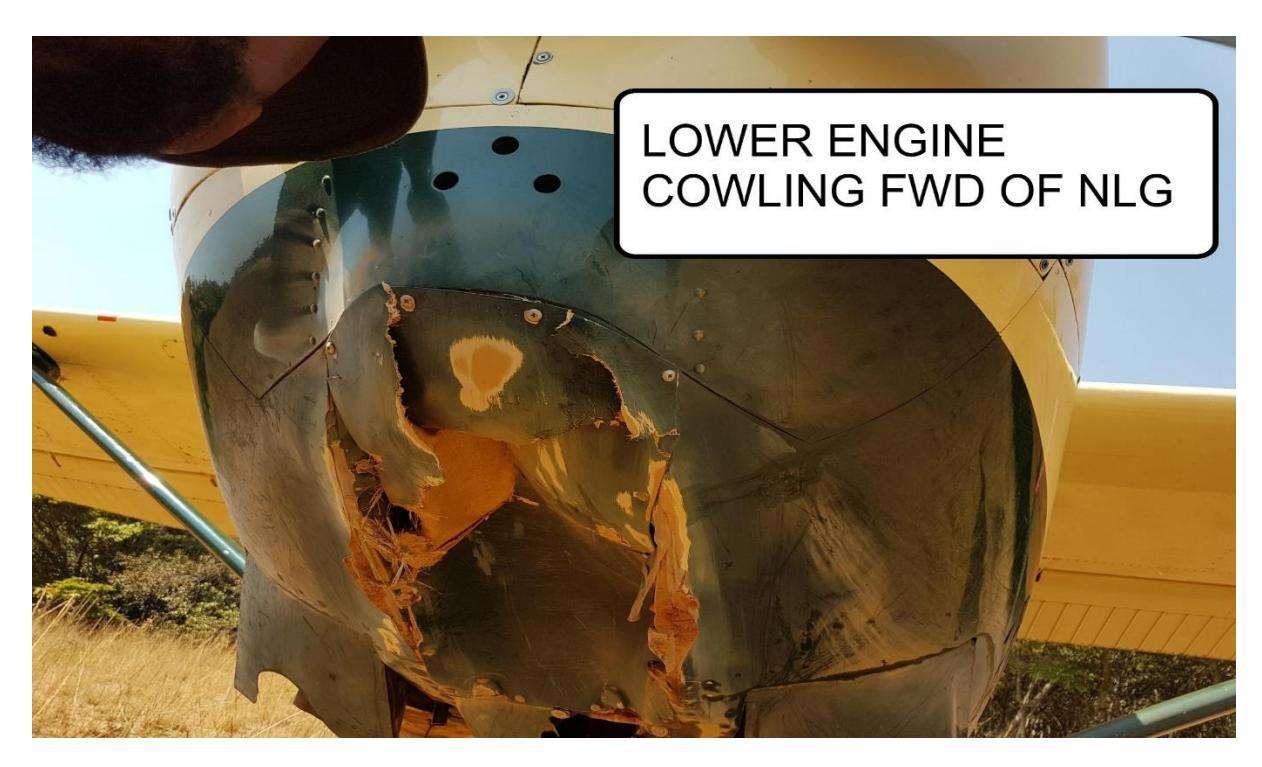
Fig.2: Lower Engine Cowling

The lower skin aft of the engine cowling ripped off exposing the main frame structure as it slid along the airfield centerline (Fig.2).

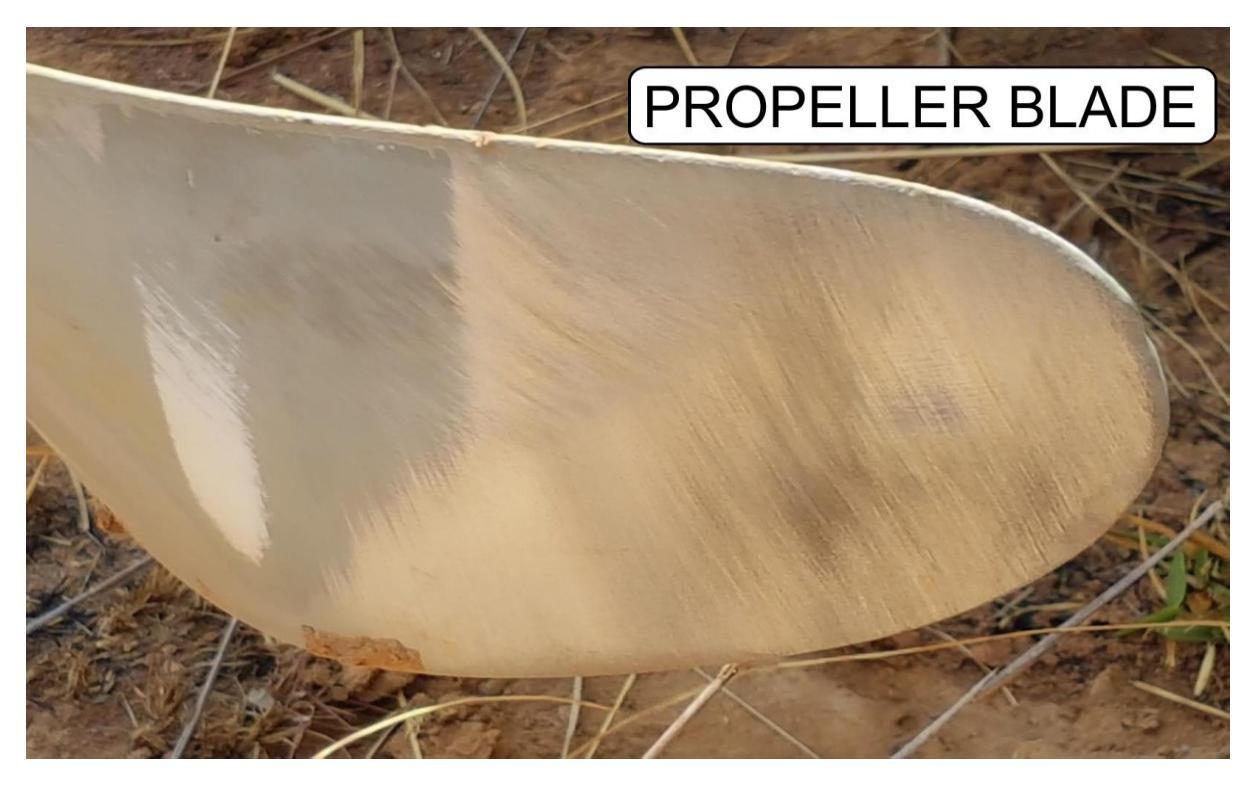
Fig.3: Bended Propeller Blade

The three propeller blades were bent backwards on impact with the ground as it was evident by the ground marks that the engine was still running on impact with the ground and during the initial stages of the slide on its belly (Fig.3).

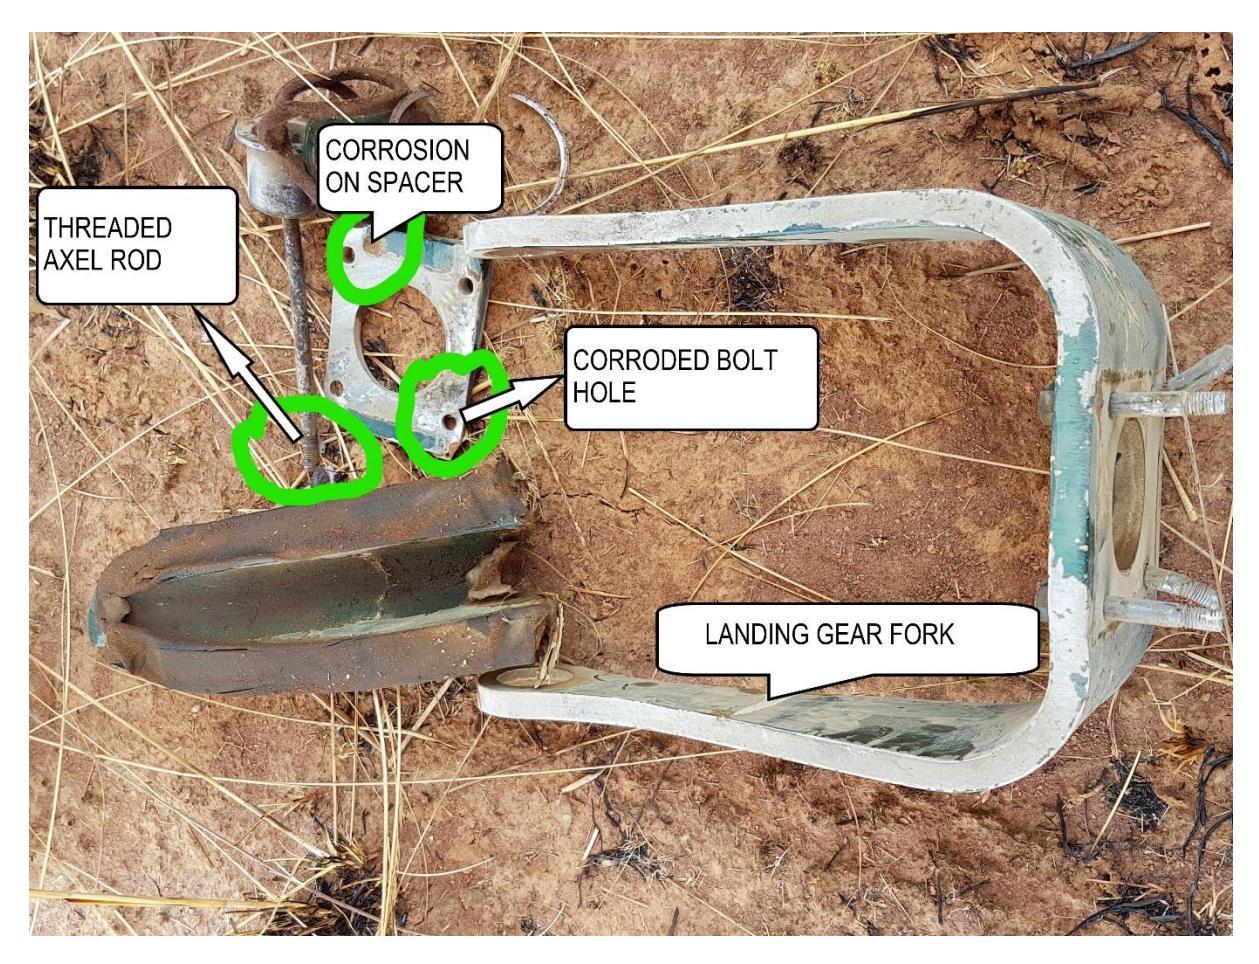
Fig.4: Corroded Parts of Landing Gear

The nose gear wheel bearings and sleeve were loose while the tire remained inflated. The Axle bolt, showed signs of corrosion, and was detached from the nut and evidence showed that there was no split pin prior to the nose wheel detaching from the fork. It was bent a quarter way from the head, with scratch marks resulting from it pulling out of the sleeve (Fig.4).

The axle bolt and the spacer between the fork- to- shock strut attachment showed clear signs of corrosion (Fig.4).

Evidence collected on the wreckage indicates that there was no safety split pin to hold the axel bolt nut. Search on the runway and proximity of the wreckage were unsuccessful. The split pin was then most likely not in place at the time of departure.

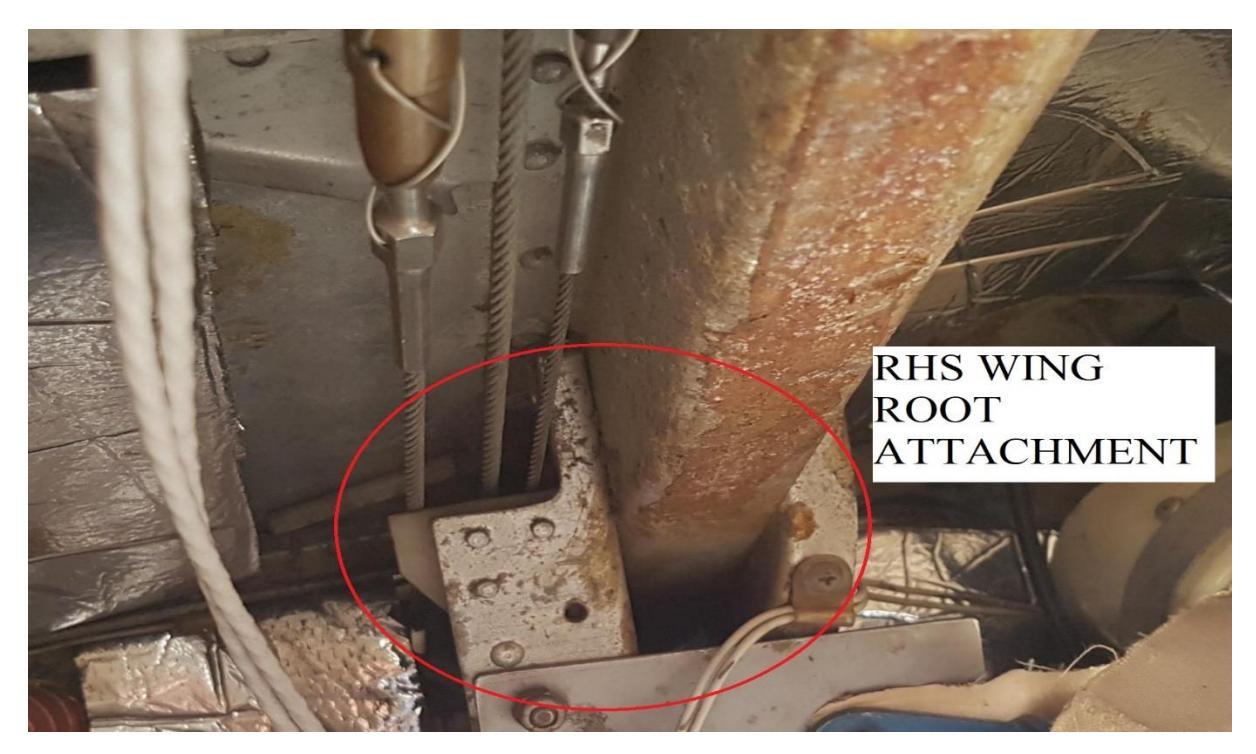
Fig.5a: Right Hand Side Wing Root

The body to wing attachment area fairing strips had a couple of screws missing or loose on both the Right-Hand Side (RHS) and Left-Hand Side (LHS) wing root area (Fig.5a and Fig.5b).

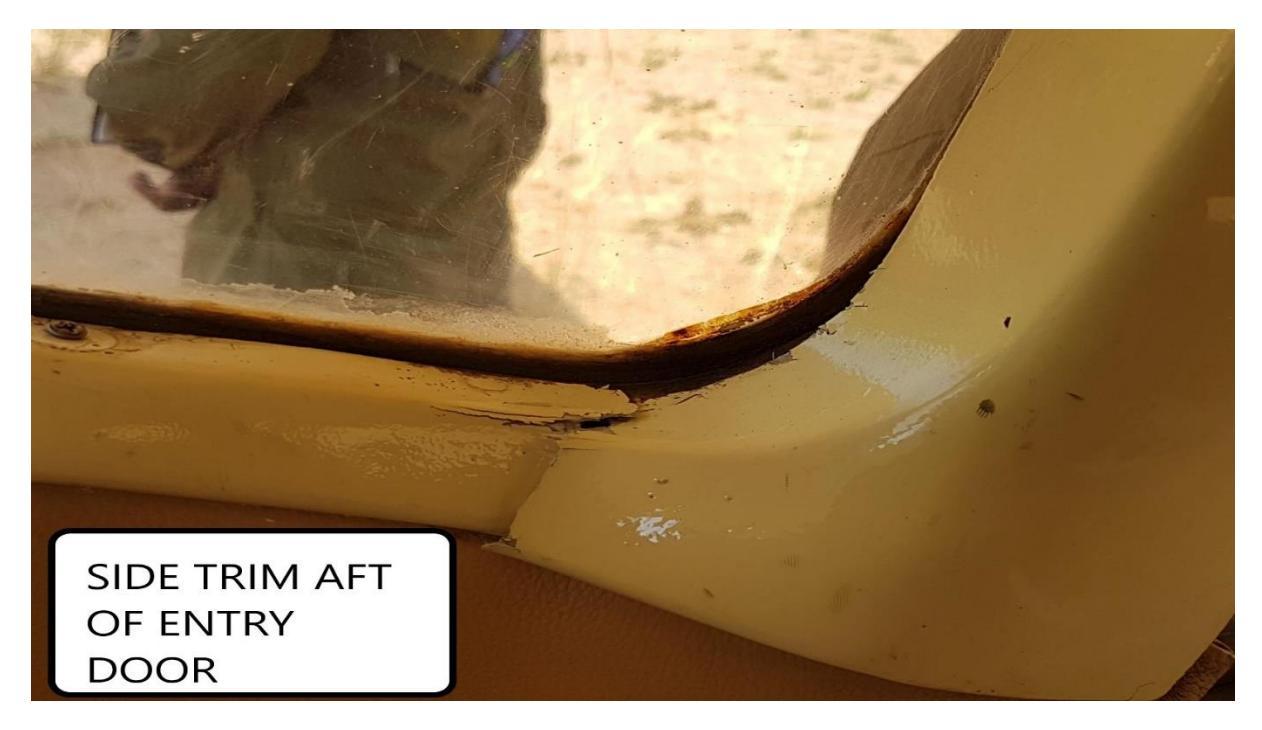
Fig.6: Side Trim Aft of Door Entry

The side-lining panel around the bottom forward LHS corner was broken just aft of the entry door (Fig.6)

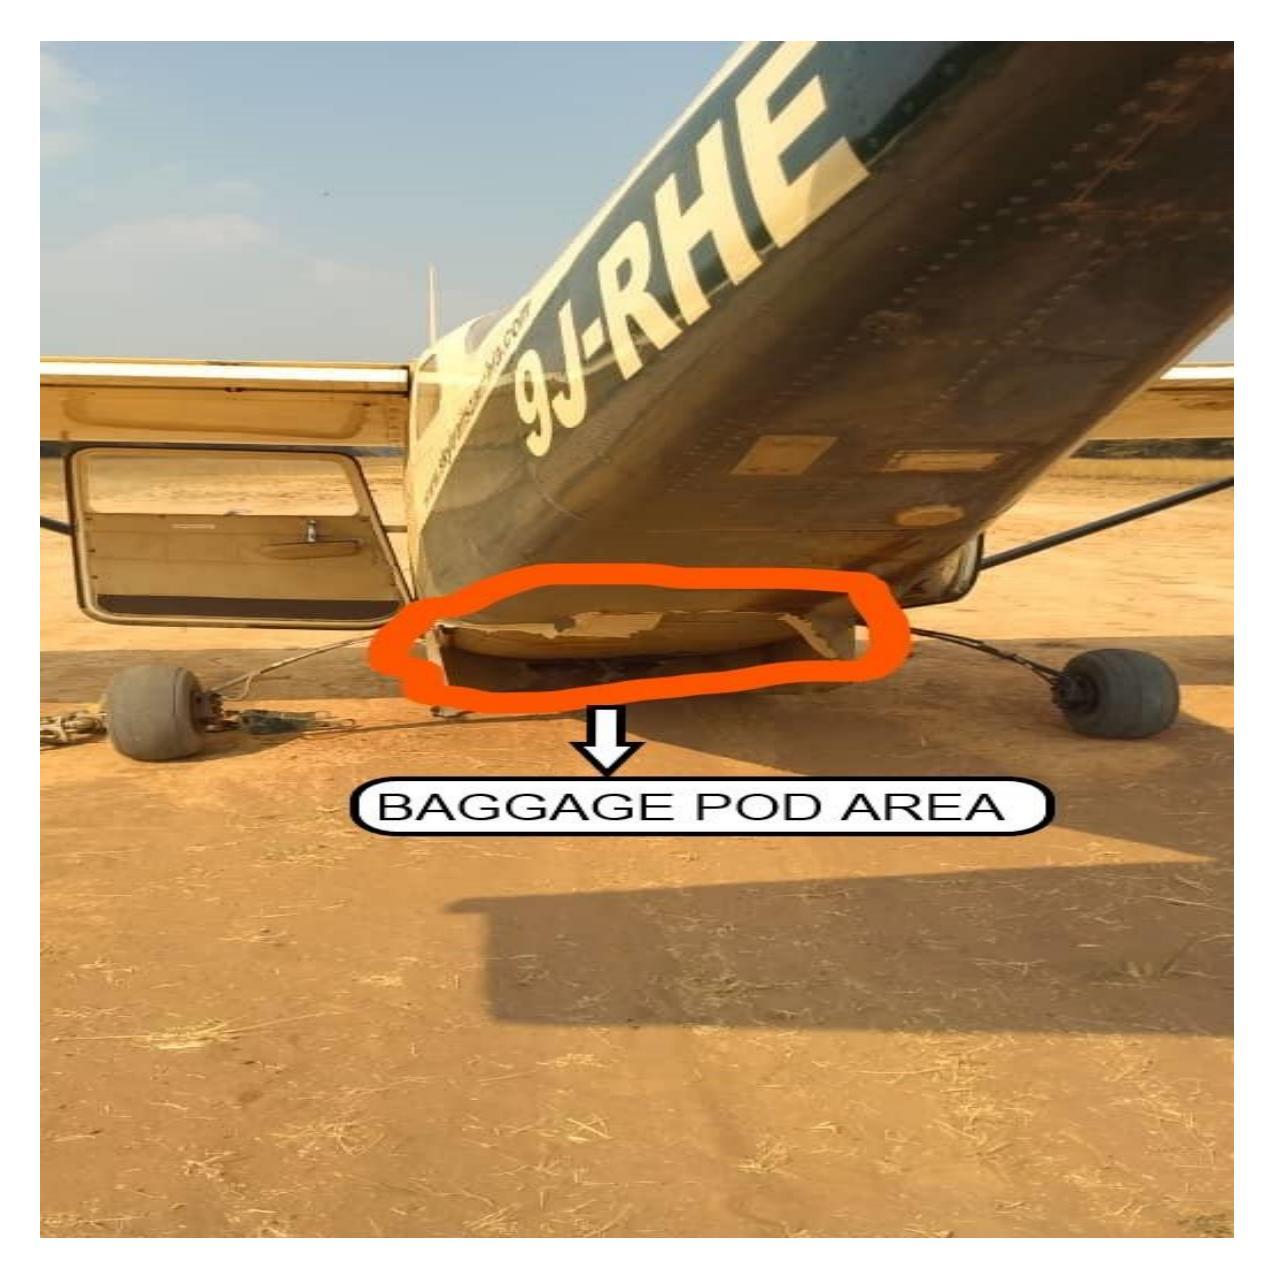
Fig.7: Baggage Pod Area

The larger portion of the airframe structure and all wings and flight control surfaces were intact. There was no evidence of detachment of the wings or flight controls prior to or after the impact. The lower and upper skin on the wings was neither warped nor twisted and the rivets too, were undisturbed all along the upper, sides and lower fuselage structure. No evident damage was sighted on the empennage and rear fuselage area. The impact damage was mainly on the nose oleo strut and the baggage pod area, underneath of which the lower skin was ripped open during the skid following the breakage of the oleo strut and detachment of the fiber glass baggage pod (Ref to Fig.7)
