# AIRCRAFT ACCIDENT INVESTIGATION BOARD

# FINAL AIRCRAFT ACCIDENT REPORT FOR A CESSNA U206 9J-RHE THAT OCCURRED ON 3<sup>RD</sup> SEPTEMBER, 2019 IN SHIWANG'ANDU, MUCHINGA PROVINCE

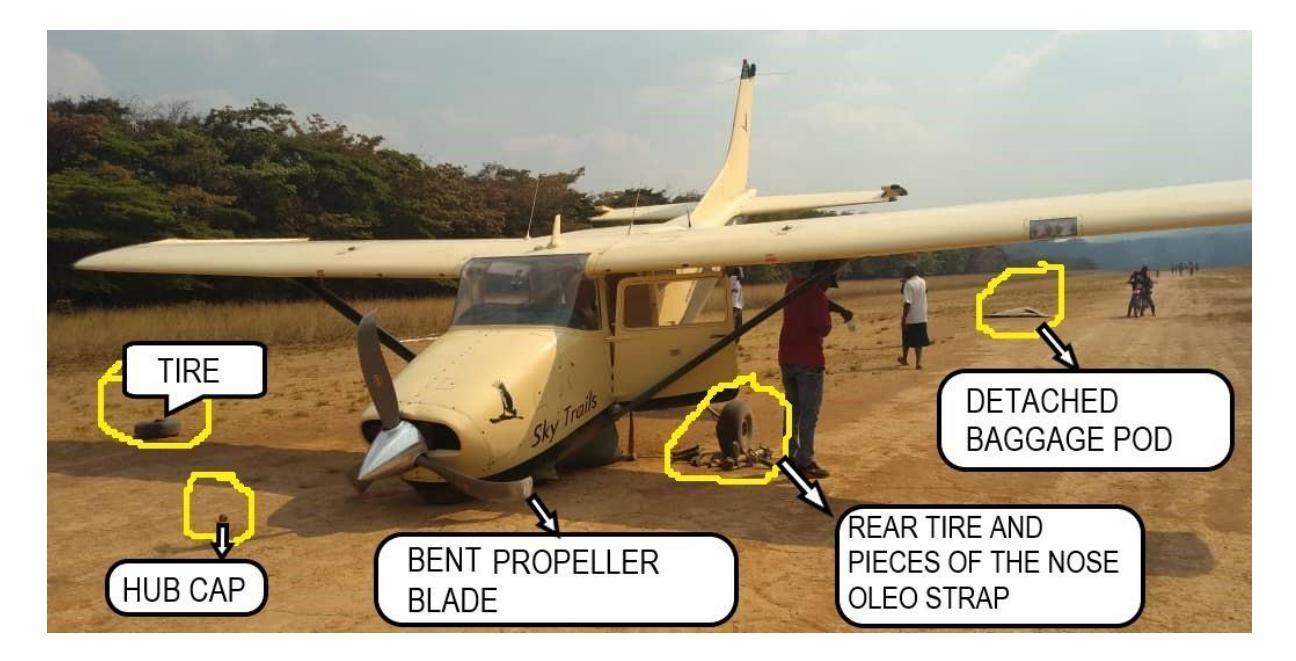
Fig.2: Lower Engine Cowling

The lower skin aft of the engine cowling ripped off exposing the main frame structure as it slid along the airfield centerline (Fig.2).
